2011: Lessons Learned Rehabilitating Manholes & Pump Stations with Fibreglass Liners. Fibreglass Liners have a lot of advantages, but there are some pitfalls. These are some of the lessons learned.

LESSONS LEARNED REHABILITATING MANHOLES & PUMP STATIONS WITH FIBREGLASS LINERS

Ken Holyoake, Managing Director, ARMATEC Environmental Ltd

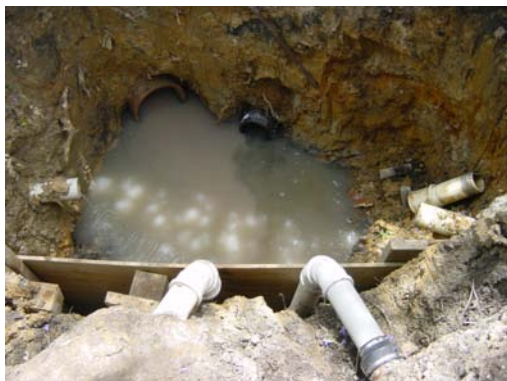
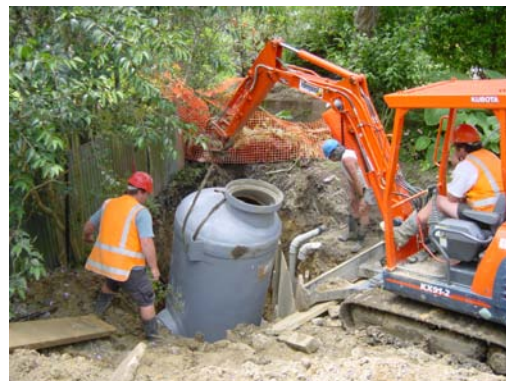
Photographs 1 & 2: 100 year old leaking manhole in location with difficult access replaced with new fiberglass manhole with sewer live throughout the installation.

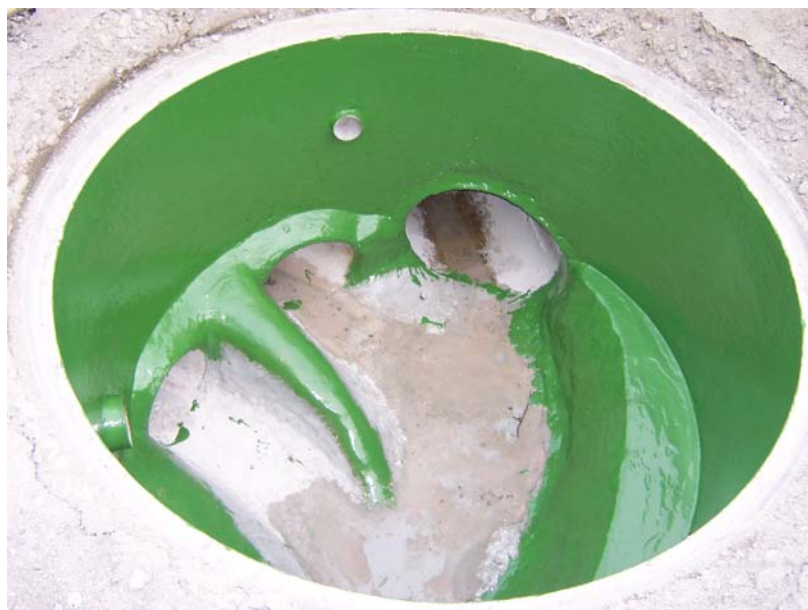
Photograph 3: Manhole in dairy factory chemical drain coated with moisture tolerant and chemically resistant ARMALINE 1730 epoxy coating. Complex shapes require rehabilitation by coating.

Specialist coatings are used due to the complex shapes of manhole bases, with inlet and outlet pipes and haunching done to shape the flows. Successful coatings used are moisture tolerant epoxy coatings, formulated to give ultra low permeation and excellent chemical resistance. One coating that has a successful track record in this application is ARMALINE 1730 from ARMATEC. This moisture tolerant epoxy coating can adhere to a damp substrate and cure underwater. It is applied by hand application to a thickness of 1 to 3mm.

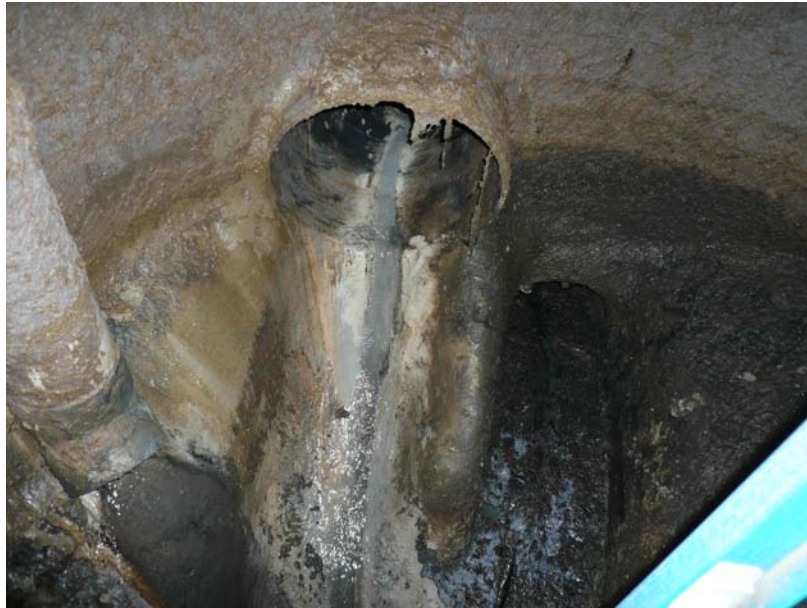
Photograph 4: Base of deep manhole in municipal sewer system coated with moisture tolerant and chemically resistant ARMALINE 1730 epoxy coating. Again, complex shapes require rehabilitation by coating.

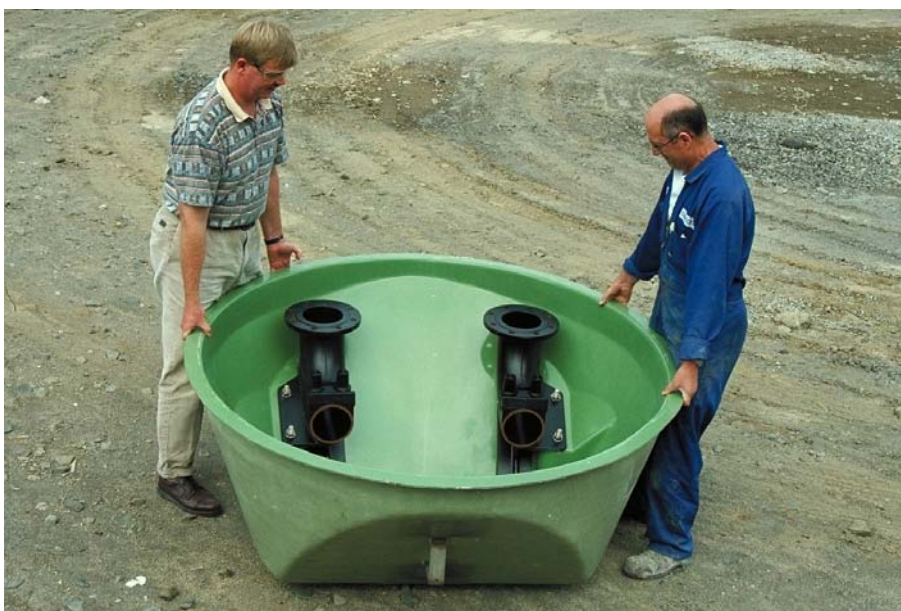
Photograph 5: FLYGT TOPS fiberglass base, with pump seating elbows installed, ready to install

The base of a pump station can be rehabilitated with coatings as described above, or a specialist fiberglass ‘TOPS’ base can be fitted when FLYGT pumps are used. This base can also be installed in new installations. The fiberglass base is factory fitted with the pump seating elbows bolted to the base and has a flange around the top for stability (Photograph 5).

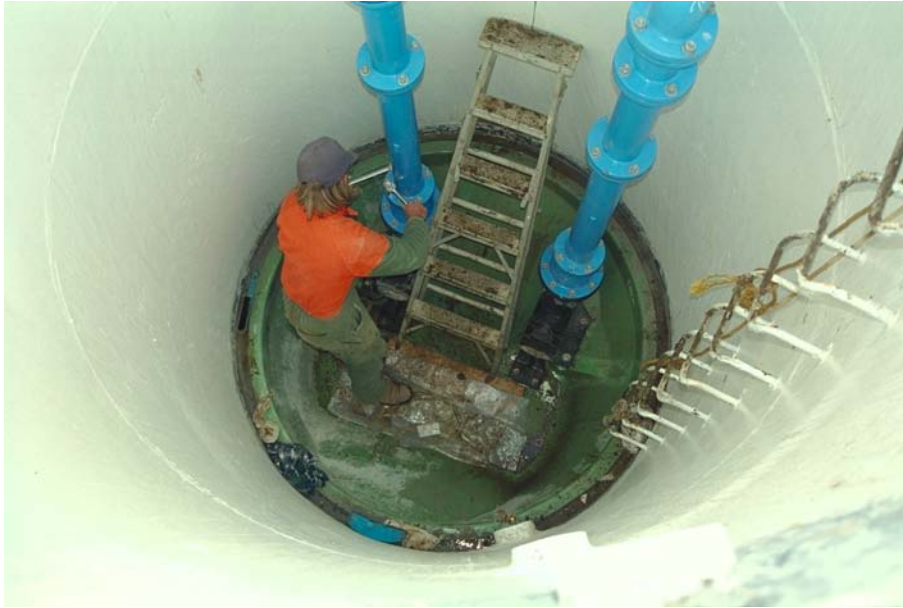
Photograph 6: FLYGT TOPS fiberglass base installed in bottom of new deep pump station. A protective coating has been applied to the wall of this new pump station.

The size of the base is selected to suit both the pumps and the internal diameter of the pump station. Once the manhole is cleared off the existing pumps and piping, the base is lowered to the bottom of the pump station, oriented correctly, and then the cavity between the fiberglass and the pump station wall is grouted with a flowable cement grout.

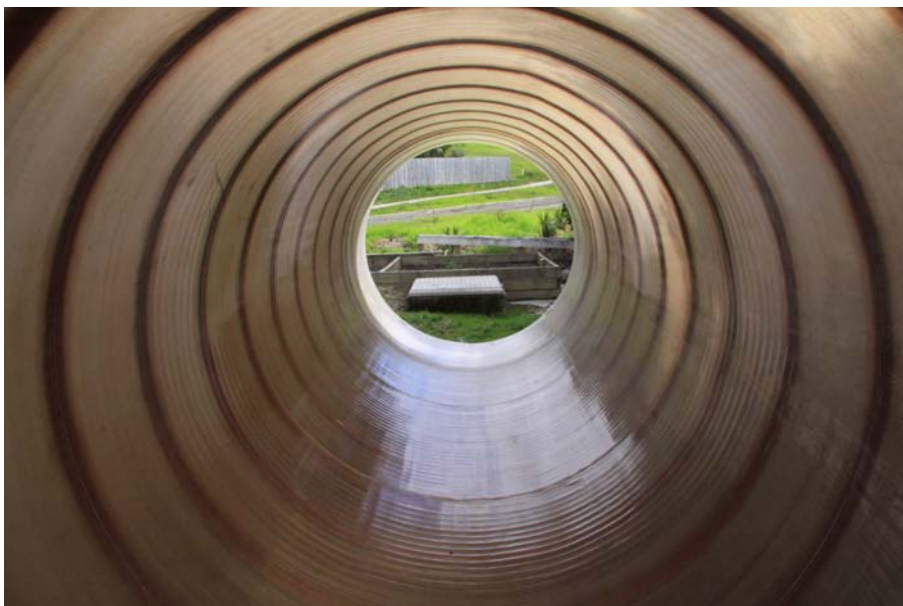
Photograph 7: Fiberglass liner ready to install. The dark rings are external stiffening rings to resist buckling during grouting after the liner is installed.

The fiberglass liner is custom manufactured to suit any diameter and depth. The thickness of the fiberglass liner is custom engineered, from 6mm upward, to resist buckling during grouting after installation. The fiberglass liner can be designed to provide as much additional structural strength as needed. Isophthalic polyester resins are used for municipal sewerage systems, and vinyl ester resins are used for industrial systems handling CIP chemicals.

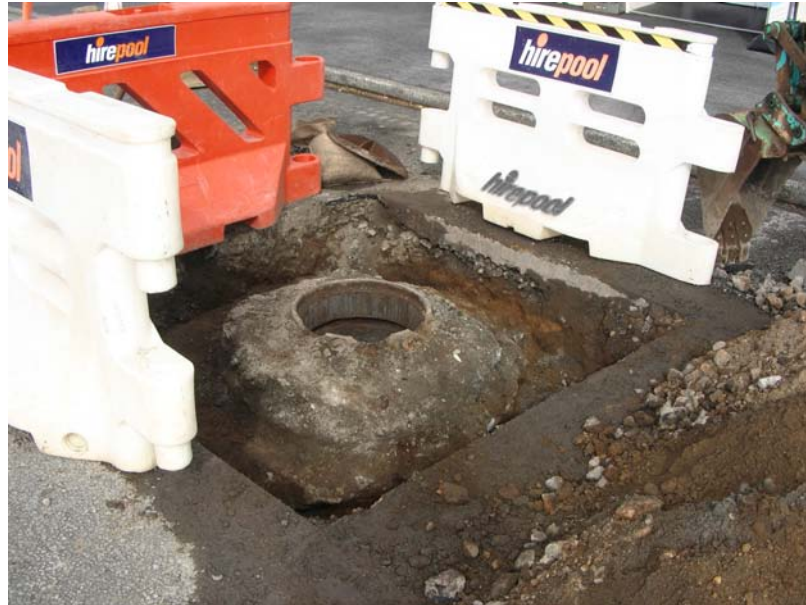
Photograph 8: Minimal excavation to remove manhole top in preparation for installing fiberglass liner.

The top of the manhole or pump station must be removed to allow the fiberglass liner to be installed. This excavation is relatively small (Photograph 8) compared to removing and replacing the entire unit. In some instances, where the surrounding soil is unstable, very large excavations may be required.

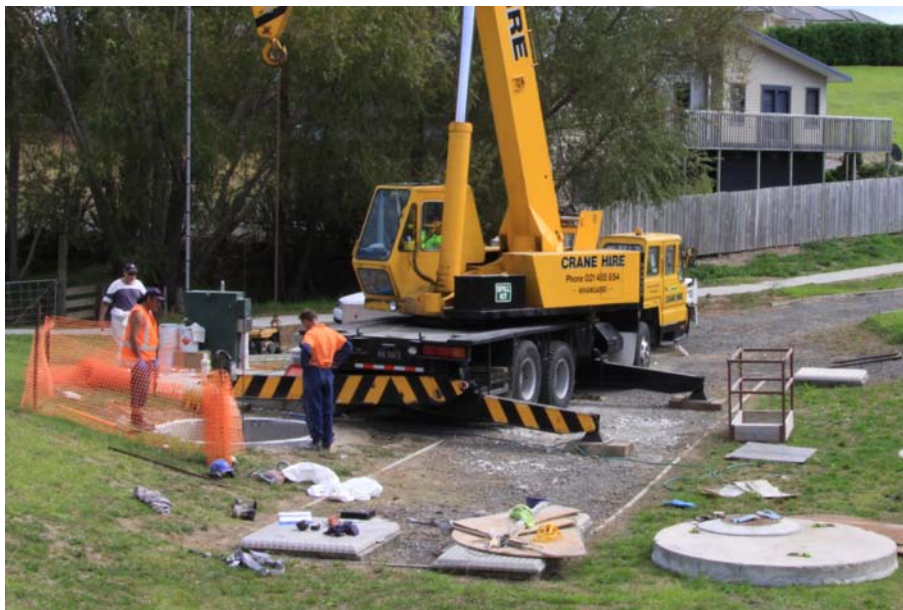
Photograph 9: Top off manhole, and preparing to install fiberglass liner.

A protective coating is applied to the underside of the top before it is reinstalled.

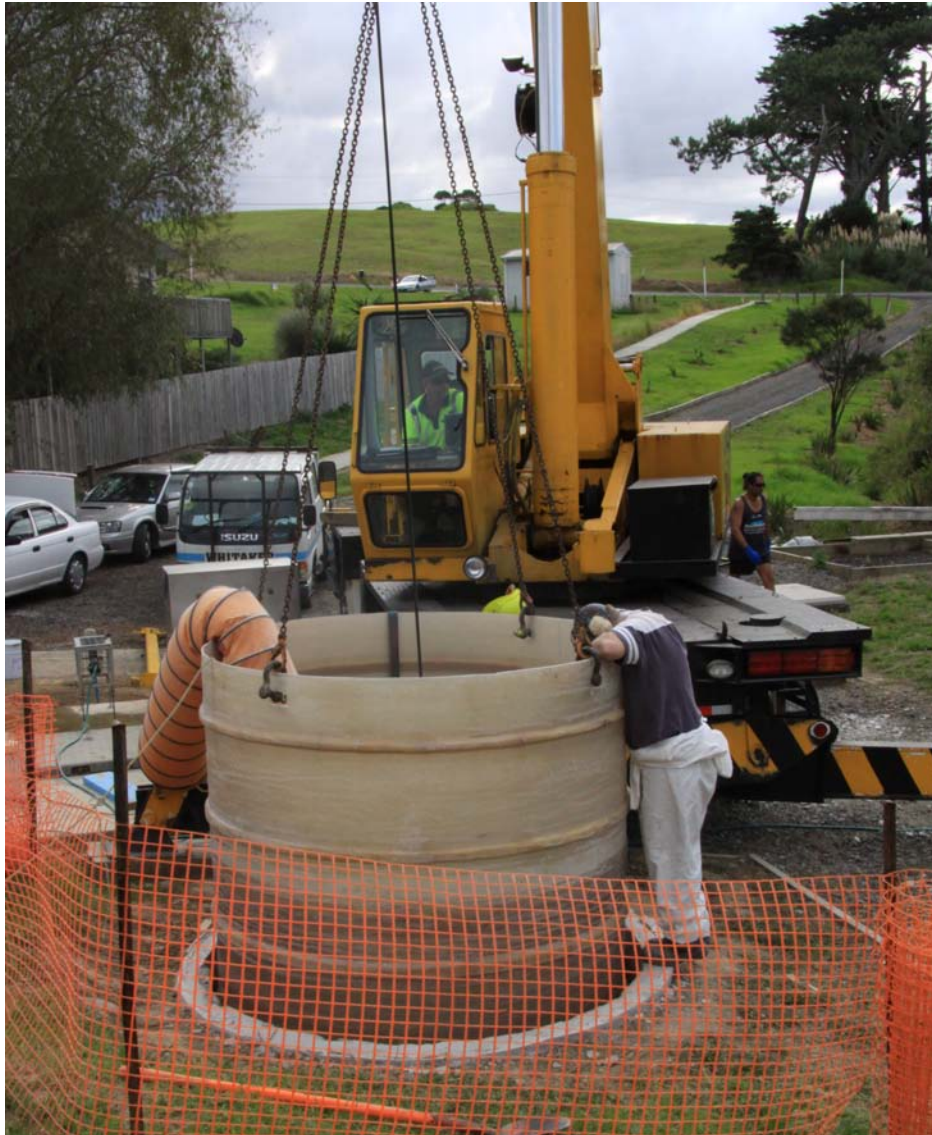
Photograph 10: Lowering a fiberglass liner into position after base is completed.

The fiberglass liner is lowered in once the base has been coated. The bottom of the liner needs to be fitted to the base to minimize gaps in preparation for achieving a seal. This may mean that it needs to be contoured to suit existing haunching, irregular shapes, or inlet and outlet pipes.

Once landed, the bottom of the fiberglass liner must be sealed to the base, so that grouting of the annulus between the existing structure and the fiberglass liner can be done. The first step in this process is to fill any gaps, and this can be done with a variety of materials including foam, putty and trowelable grout. Then a fiberglass bandage is applied from the liner to the base, and allowed to cure.

A new stiffer liner was installed once the bulges were removed (Photograph 10). The extra stiffness was achieved with a thicker wall, plus external stiffening ribs. The effectiveness of this will be monitored.

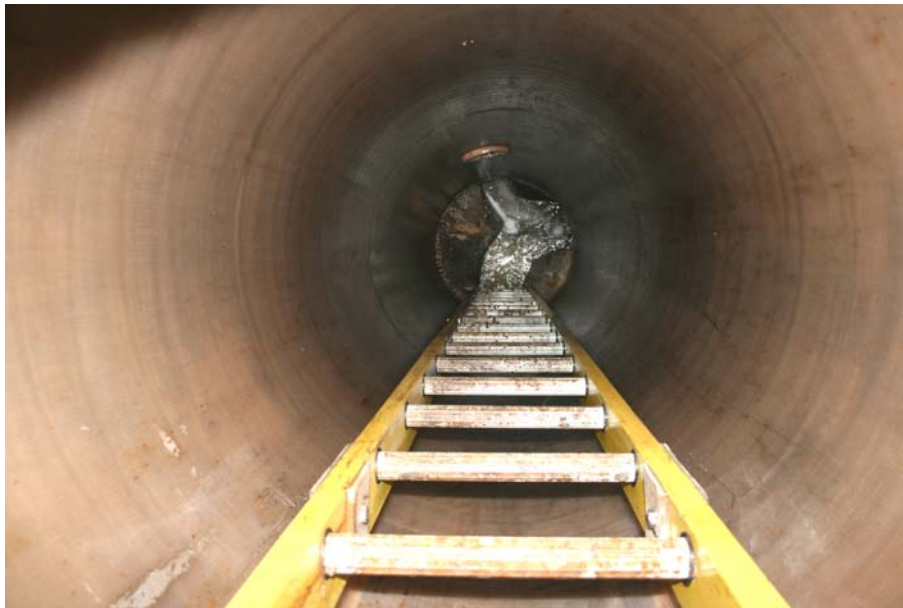
Photograph 11: Completed fiberglass liner

The end result is a manhole or pump station with a lining that has an indefinite life. The smooth internal fiberglass surface is corrosion resistant and easily cleaned.

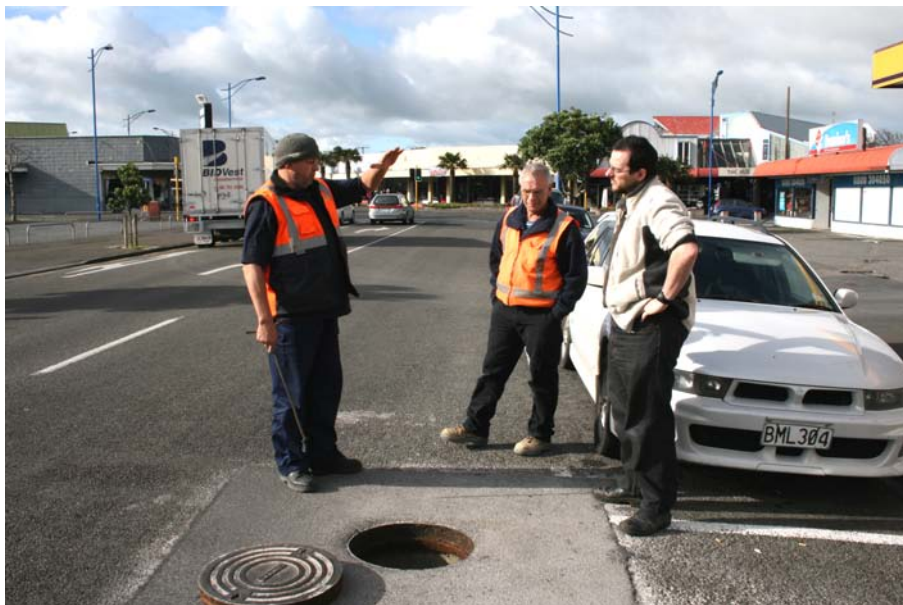
Photograph 12: Completed installation with top back on and road re-instated

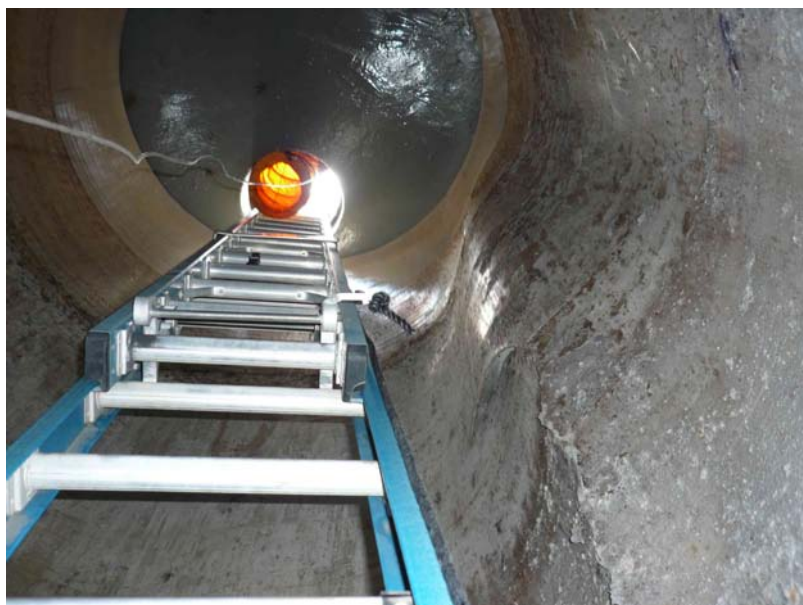
Photograph 13: Fibreglass liner bulged during installation, and cracked during operation due to repeated temperature fluctuations. This manhole/pump-station was originally coated concrete that failed within 1 year.

Secondly, when grouting the annulus, the pour depths had to be reduced, but were exceeded. This caused the liner to bulge inwards in a number of places each time this happened.

At the finish of installation, the bulges were clearly evident, but were mainly cosmetic. The fiberglass liner was intact and performed its function. A watch was kept on this once the manhole was closed back in.

The fiberglass liner cracked and failed within 3 months of installation. Cracks formed centred on the apex of the bulges. It was determined that the cause of the failure was repeated temperature fluctuations as the wastewater level rose and fell in the manhole/pump-station during day-to-day operation. These temperature fluctuations caused thermal expansion of the fiberglass, and this manifested itself as stress concentrations at the apex of the bulges, and finally cracks once the yield point of fiberglass was reached. If the fiberglass liner had been exactly round, the stresses from the thermal expansion would have resulted in compressive forces in the fiberglass as it tried to expand against the grout, and with no irregularities like bulges, the fiberglass would have stayed in position and been fine.
